# TESTING OF A DELTA IV PAYLOAD ATTACH FITTING (PAF) SUBSTRUCTURE WITH AN INTEGRAL COMPOSITE FLANGE

*John E. Higgins*

Air Force Research Laboratory, VSSV  
Kirtland AFB, NM USA

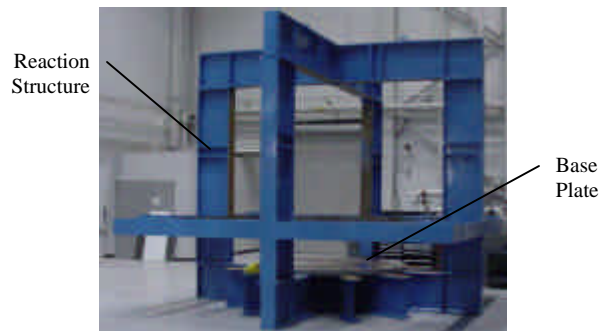
The 360-degree PAF substructure tests were conducted in a general-purpose steel frame load fixture commonly referred to as a reaction structure. The reaction structure in Figure 2 was used previously to flight qualify two payload adapter structures (EELV Secondary Payload Adapter (ESPA) for the EELV launch vehicle and a Multiple Payload Adapter (MPA) unit for the Minotaur launch vehicle). Because applied loads of earlier tests were well below the 2,224 kN (500,000 lbs) PAF axial load requirement, reaction structure stress and deflection magnitudes were analytically verified prior to the test. Displacement variation tolerances at the base of the test article, away from the composite flange, were required by Boeing to not exceed 0.76 mm (0.030 in). Both the frame peak stress and the displacements of the 13.3 cm (5.25 in) thick steel base plate were confirmed by analysis illustrated in Figure 3.

Figure 2. Reaction Structure with 13.3 cm thick circular base plate

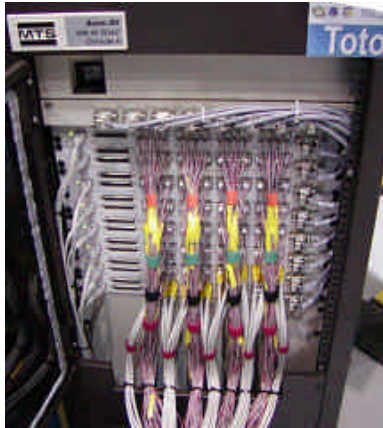
Instrumentation channels were conditioned, monitored, and recorded with a 256-channel Agilent® data acquisition system. The software interface, developed by MTS®, integrated and synchronized strain and displacement measurements with an Aero90 load controller. With this capability, both load cell bridges were recorded in concert with the instrumentation channels, thereby providing synchronized external load and response measurements. Additional software allowed the operator to monitor an unlimited number of channels during test operations while providing minimum and maximum limits used to suspend load application when reached. All channels, including load cells, were recorded at 1% increments of the flight load

while ramping up to the desired peak load for each cycle. When returning to zero load, however, data was recorded at 5% load increments. The fully populated data acquisition system is shown in Figure 8.

Figure 8. Populated Data Acquisition System
